Manhole Inspection Summary

Manhole # S19AA_002MH

Insp Date: **10/31/07 11:08 AM**

Location Address: **2201 MOSHER ST**

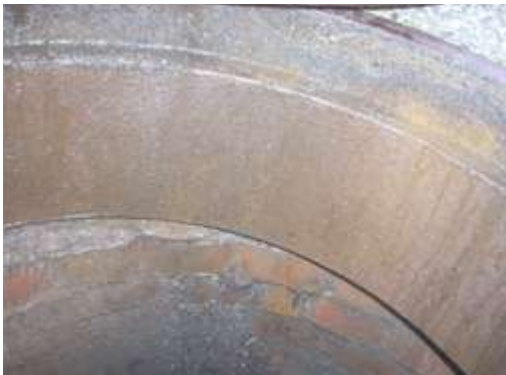
Defect 3

Infiltration: ☐ None ☐ Joint ☐ Cracks ☐ Mortar ☐ Roots ☒ Wall

CORBEL INFILTRATION

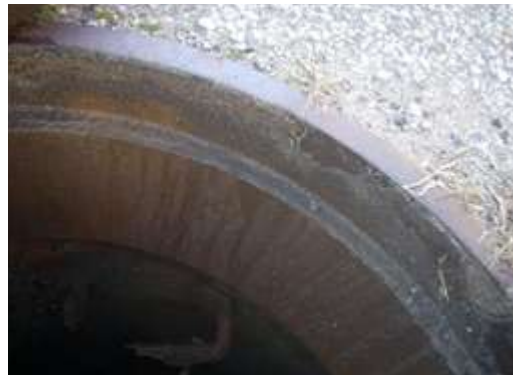
Defect 2

Count: **3** Missing: **1** ☒ Corroded

MISSING STEP

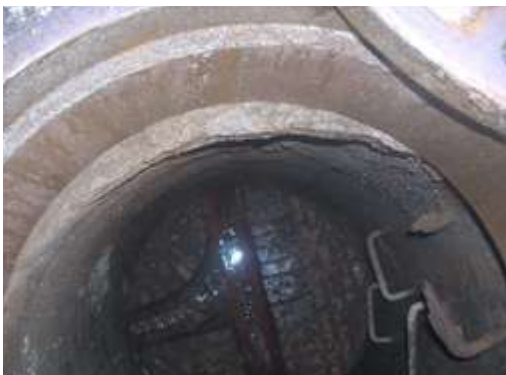
Defect 1

Offset: **1** (in.)

FRAME OFFSET

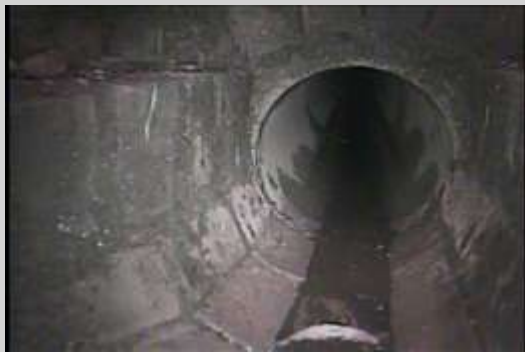
12 O'Clock Outflow

8 in. Circular Gravity Sewer
Pipe Out @ 12 O'Clock

Pipe Height: **8.4** (in.) Rod and Bar (Angled)
Pipe Material: **Clay** ☐ Pipe Lined
Invert Depth: **8.65** (ft.) Flow Characteristics: **Slow**
Deposits: ☒ None ☐ Mud ☐ Sludge ☐ Debris ☐ Grease
Silt Depth: (in.) Deposits Extent:
Infiltration: **None** Pipe Seal Cond: **Sound**

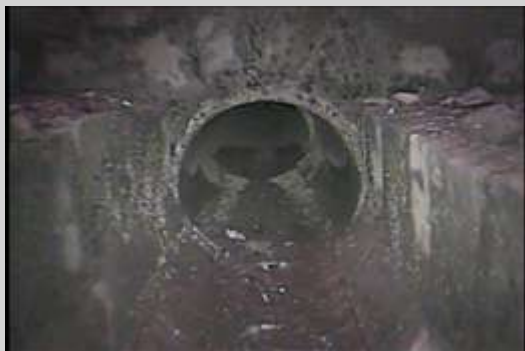
6 O'Clock Inflow

8 in. Circular Gravity Sewer
Pipe In @ 6 O'Clock

Pipe Height: **7.2** (in.) Rod and Bar (Angled)
Pipe Material: **Clay** ☐ Pipe Lined
Invert Depth: **8.63** (ft.) Flow Characteristics: **Slow**
Deposits: ☒ None ☐ Mud ☐ Sludge ☐ Debris ☐ Grease
Silt Depth: (in.) Deposits Extent:
Infiltration: **None** Pipe Seal Cond: **Sound**

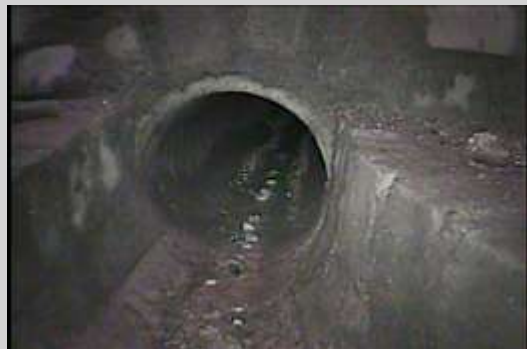
9 O'Clock Inflow

8 in. Circular Gravity Sewer
Pipe In @ 9 O'Clock

Pipe Height: **7.2** (in.) Rod and Bar (Angled)

Infiltration: **None**

Pipe Seal Cond: **Sound**
